Reference P802083C Page 1 (4)

Invacare Rea AB Box 200 343 75 Diö

Crash testing of wheelchair XLT Swing according to ISO 7176-19:2001

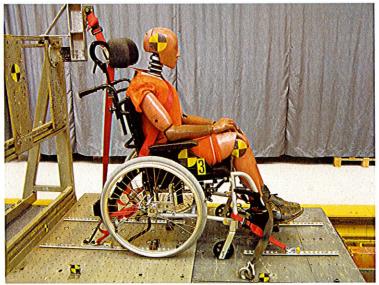
Figure 1 Test setup

The test object was mounted in a forward direction and attached to the sled with a 4-point tiedown system from Unwin. A Hybrid III-dummy, 76 kg, was positioned in the test object. The sled was accelerated to a speed of 48.6 km/h before impact.

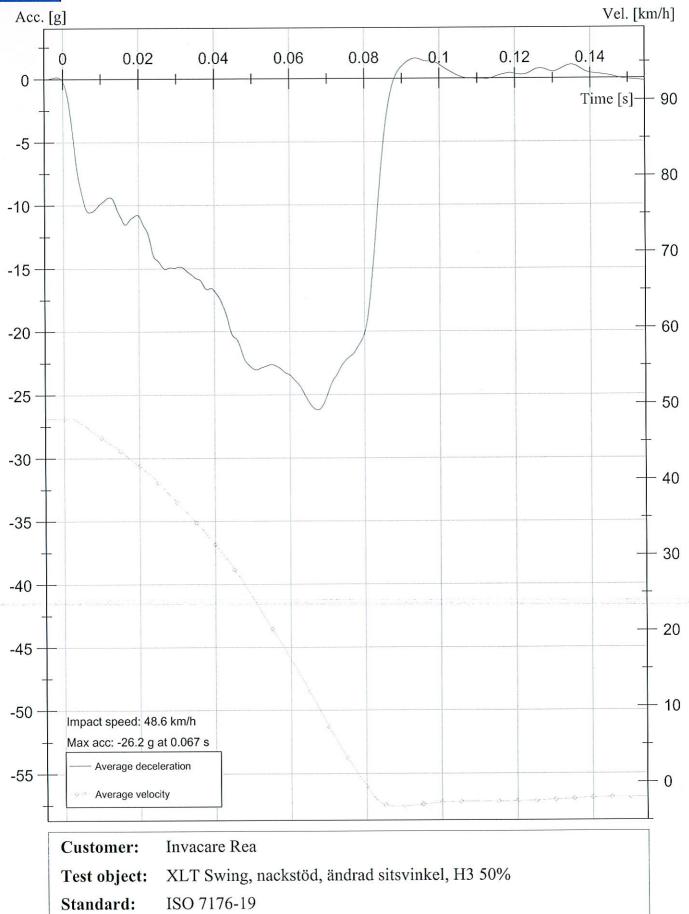
Sled deceleration, Average pulse, CFC 60

$15g\ during\ 40\ ms,\ 20g\ during\ 15\ ms,\ 48\text{-}50\ km/h$ (pulse id: 2).
