Reference P800980

Crash test of the Typhoon II wheelchair and Typhoon docking station according to ISO 10542

A crash test of the Typhoon docking station for the Typhoon II electrical wheelchair has been performed according to ISO 10542-3:2005, section 6.1.

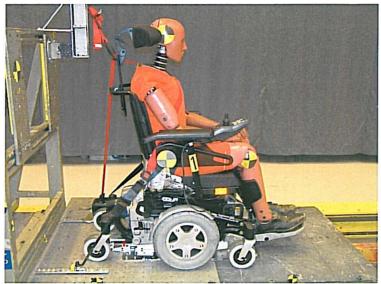
Figure 1 Test setup

The test object was mounted directly on the sled in a forward direction and the wheelchair was attached to the docking station. A Hybrid III-dummy, 76 kg, was positioned in the test wheelchair and restrained by an Unwin belt.

The sled was accelerated to a speed of 50.6 km/h before impact.

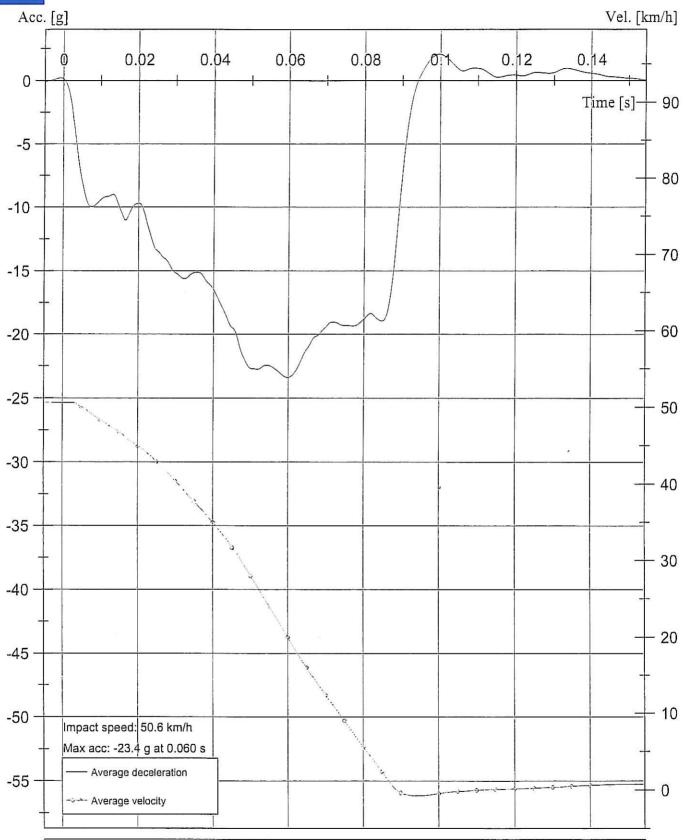
15g during 40 ms, 20g during 15 ms, 48-50 km/h (pulse id: 2)

Sled deceleration, Average pulse, CFC 60

Two accelerometers mounted on the sled, inv no 403201 and

403215. The graph can be found in appendix 1.
